TOWN OF LAKE COWICHAN

Public Works and Environmental Services Committee

Tuesday, February 18th, 2020 at 6:00 p.m. – Council Chambers

PW 20-02-18
7(d)

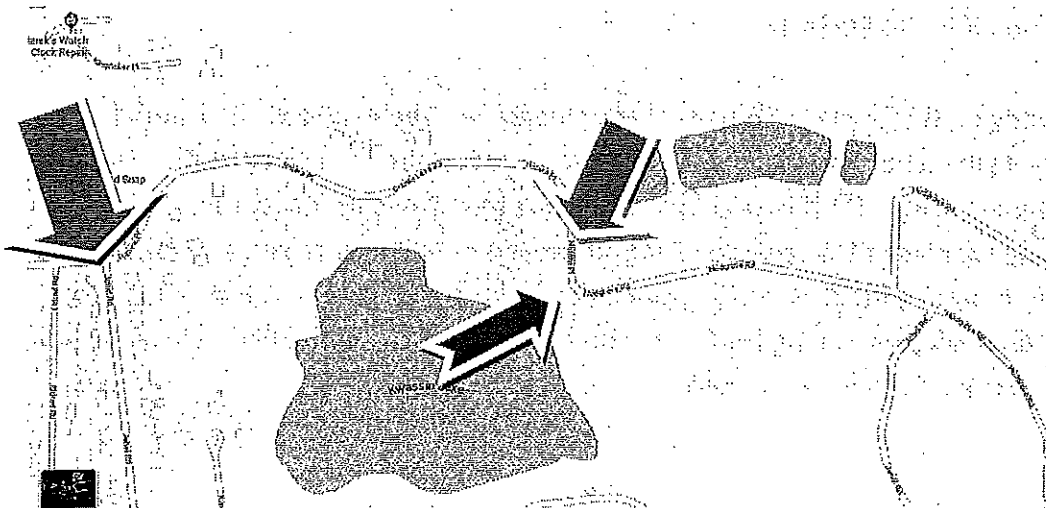
Speed limit between Johel Road to Hudgrove Road reduced to 30km/hr. Road between two fat arrows arrows.

Corner of Natara Pl and Hudgrove Rd reduced to 10 km/hr. Area of thinnest arrow

Hazard signs with arrow to be posted at either side of the junction.

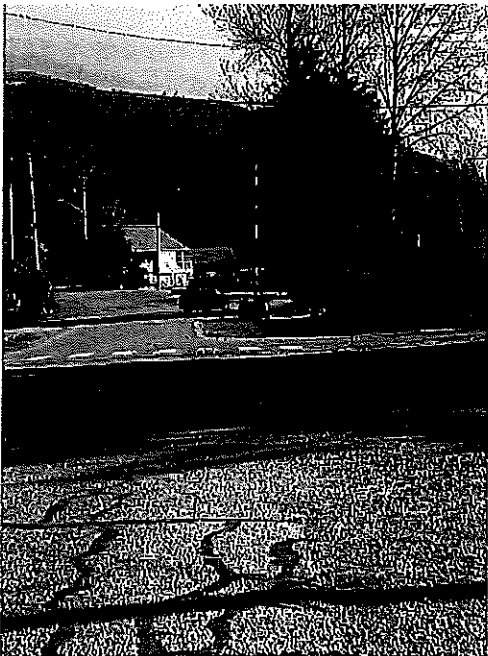
New 40 km/hr sign on Grants Lake Rd.

The 50km/hr sign has been replaced by a 40km/hr sign and relocated on the other side of the road and facing the opposite direction. A second 40km/hr sign was placed on the entrance of Grants Lake road facing the direction that leads out of town. Right turn arrow signs will be placed on the corner of Hudgrove Road in the direction of town.
